DAM REMOVAL FORUM PROGRAM

Bank Erosion Rates from Lidar DEM Change Detection and Repeat Surveying
Robert Walter and Dorothy Merritts
WSI and Franklin and Marshall College

Phase 3 WIP; Legacy Sediment, Dam Removal and Threats to Water Quality in Lancaster County

DEP Growing Greener Grant Final Report

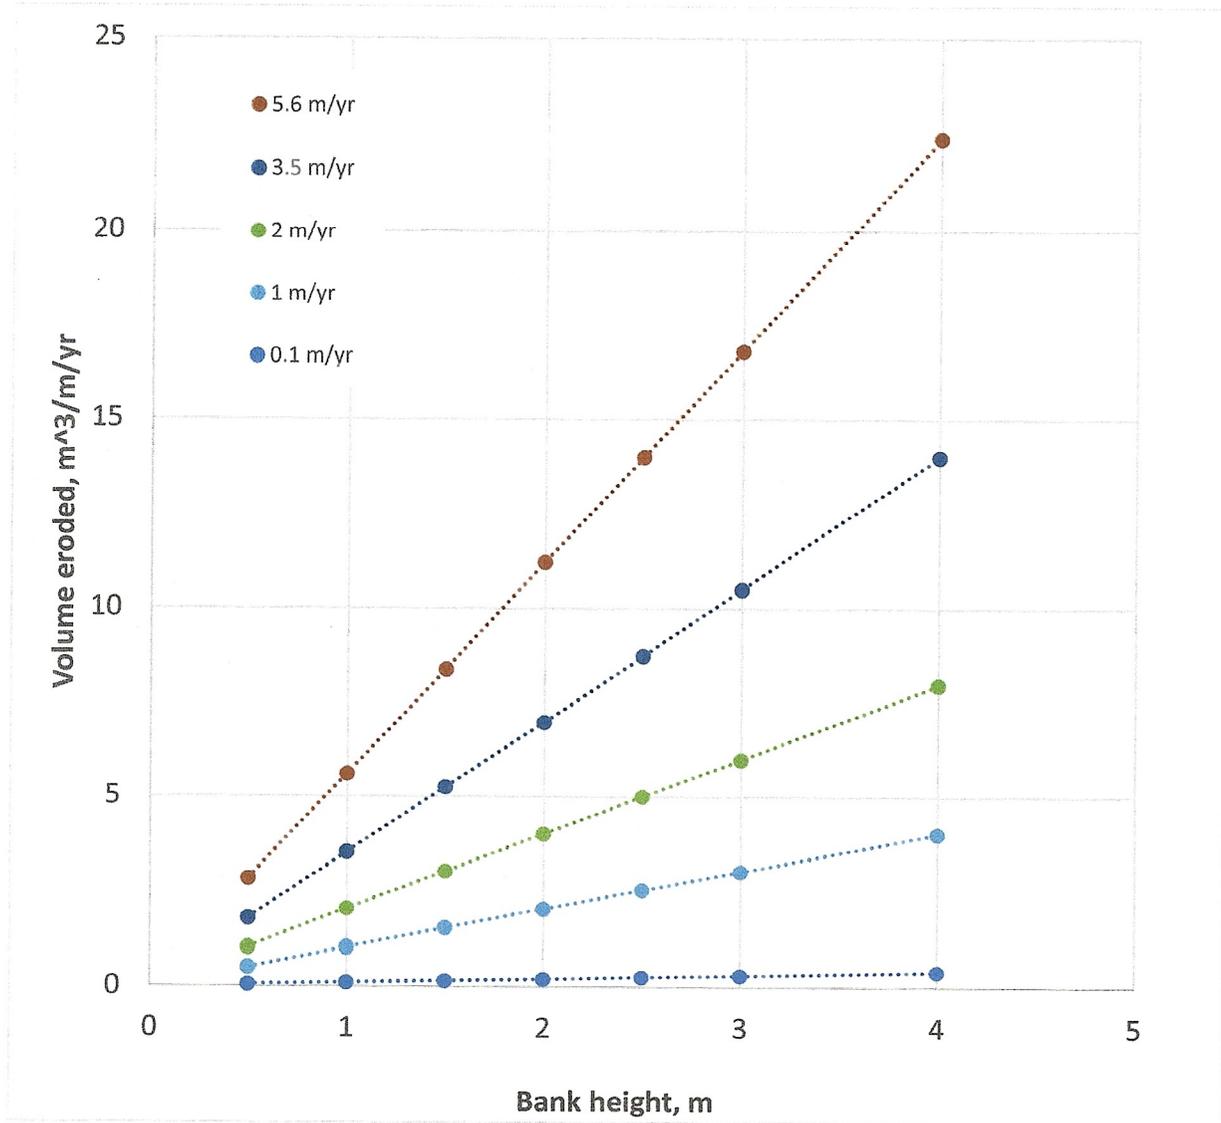
Figure 1. Volume of sediment eroded per meter of length along a channel by bank erosion plotted on y-axis, in units of $\text{m}^3/\text{m}/\text{yr}$ for different bank heights (x-axis) and lateral bank erosion rates (slope of different colored lines with corresponding colored dots).

Bank height and lateral erosion rate matter greatly when estimating volume of sediment eroded by bank erosion. Higher banks produce more sediment when eroded, and higher rates of lateral erosion produce more sediment. As a consequence, the greatest loads of sediment from bank erosion tend to be where banks are both high and eroding rapidly. The interplay of these two factors is shown in Figure 1, in which we plot the range of lateral bank erosion rates that we have measured from a combination of lidar DEM differencing and repeat surveying with GPS and drone technology. For example, if a bank height is 2 m and its bank erosion rate is 1 m/yr , then from Figure 1 we can determine that 2 m^3 of sediment is eroded from that bank

This diagram illustrates an important finding in our work. Given the range of bank heights (usually 0.5 to 3 m) and erosion rates (usually 0.1 to ~5) that we have measured in this region, the typical range of erosion volume estimates at locations where bank erosion occurs is 1 to 8 m³ per m of channel length. If the bank height is 1 m, this range corresponds to a bank retreat rate of 1 to 8 m/yr. If the bank height is 2 m, it corresponds to a slower retreat rate of about 0.5 to 4 m/yr. In other words, a bank that is 2 m high produces twice as much sediment as a 1-m high bank for the same lateral bank erosion rate.

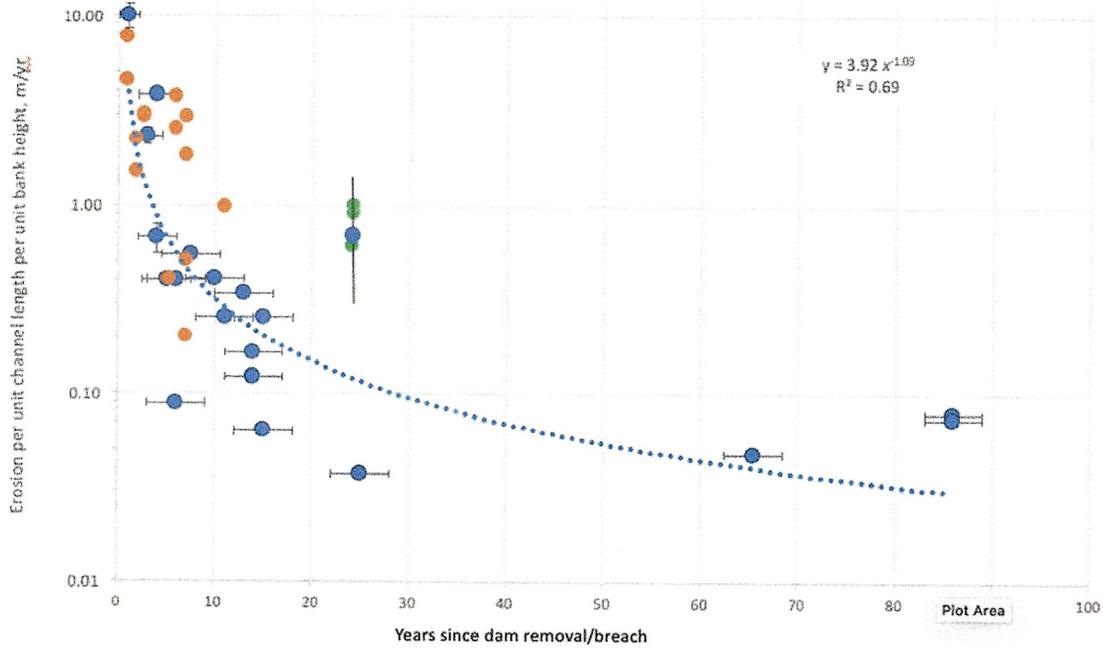
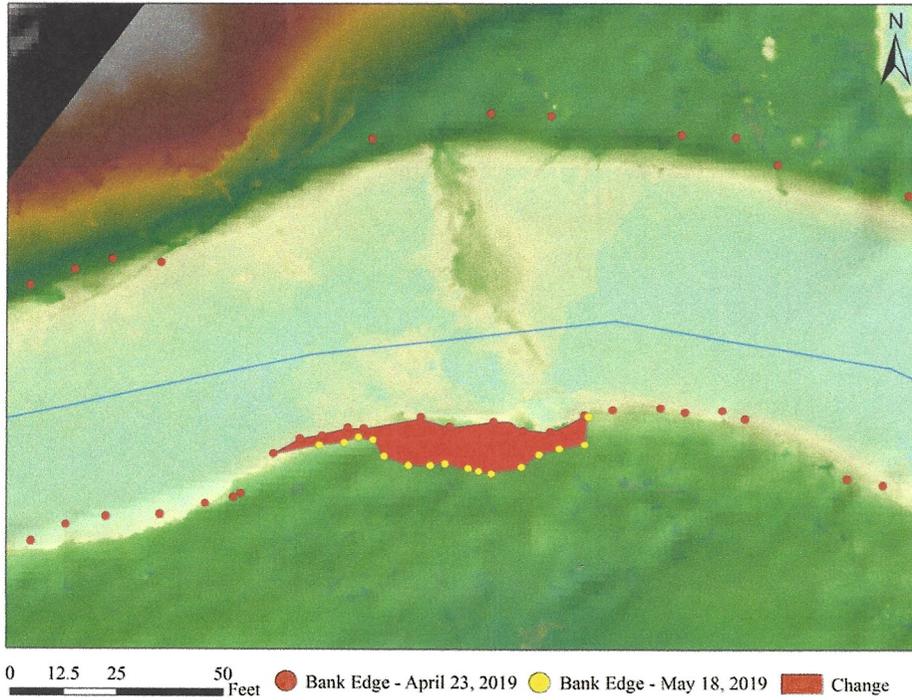
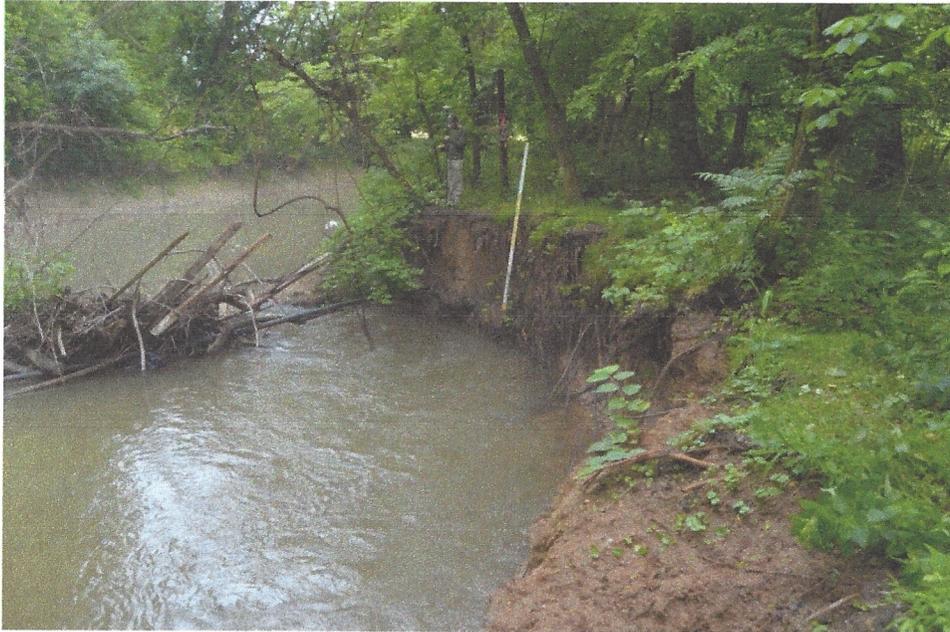
Fig. 3. (a) Repeat GPS surveying (red and yellow circles) along Chiques Creek upstream of the Krady milldam that was removed in July 2018. The dam was located ~ 400 m downstream, and its removal resulted in newly exposed high banks of former reservoir (i.e., millpond) sediment, as shown for the left bank as viewed upstream in (b). This location is about midway along the red polygon indicates recently eroded legacy sediment in Fig. 3a. Note person and 3-m-high stadia rod for scale at center of photo.

After the Krady milldam removal on Chiques Creek (3rd historic milldam upstream from mouth) in July 2018, we measured approximately 1680-2730 m³ of bank erosion of 2.1-m high banks of legacy sediment over 210 m of channel length from July to December, 2018. Our methods combined pre-dam removal bathymetric surveys and post-dam removal laser level surveying. The average bank erosion rates were ~4-9 m/yr, typical rates that we have gotten for other sites where dams were removed within the previous 5-10 years (see Figure 1). Using a bulk density of 1.1 g/cm³ yields an estimate of 1866-3033 tons of sediment eroded into Chiques Creek along this 210-m stretch during this ~0.5 yr period.

From April to May 2019, we measured via repeat GPS surveying another >70 m³ (~77 tons) of bank erosion along a relatively short distance of ~20 m at a portion of the bank undergoing rapid slumping due to undercutting from the lowered water level (Fig. 3). At this site located ~400 m upstream of the breached dam, the 2.1-m high bank eroded laterally ~4 m in just 0.1 yrs, indicative of the spatial and temporal variability of bank erosion that is associated with channel response to water level lowering after dam removal. Bank erosion at this location is associated with recent breaching of a debris jam that had formed at the channel constriction just prior to dam removal. This debris jam can be seen at left in Fig. 3. Water level lowering from milldam removal enabled the channel to cut down beneath the 2.1-m bank and then erode laterally to breach the debris jam. As a result, a new wave of bed incision and bank erosion is occurring upstream along the former millpond reservoir sediment for at least another 400 m.

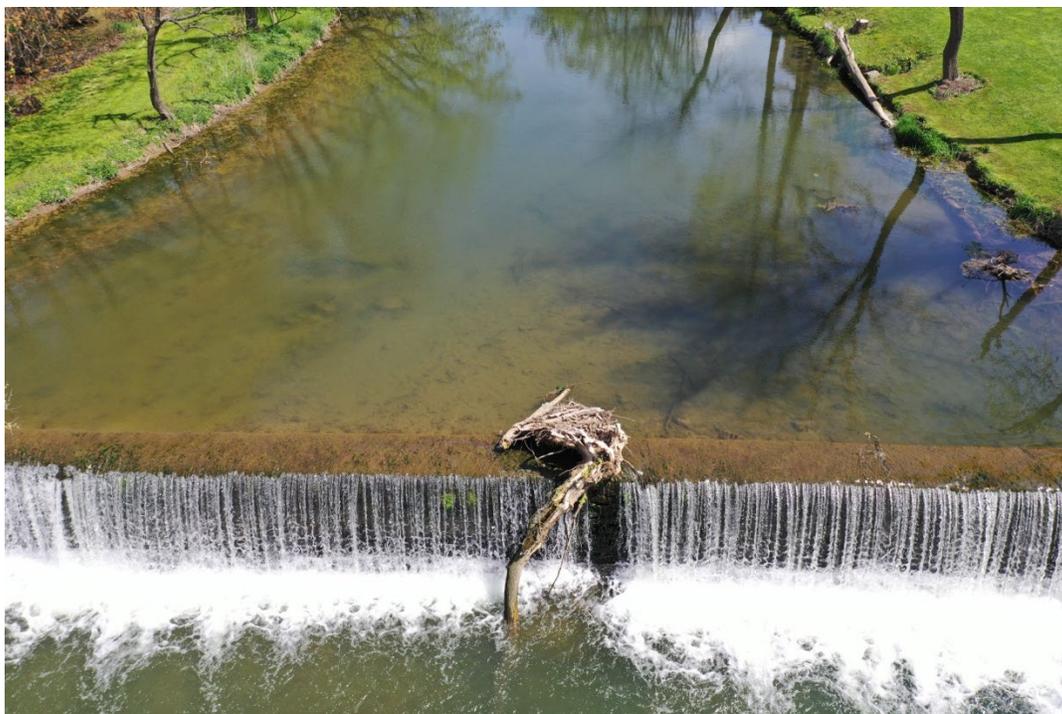
Figure 1: View of Roller Mill Dam with stored sediment.

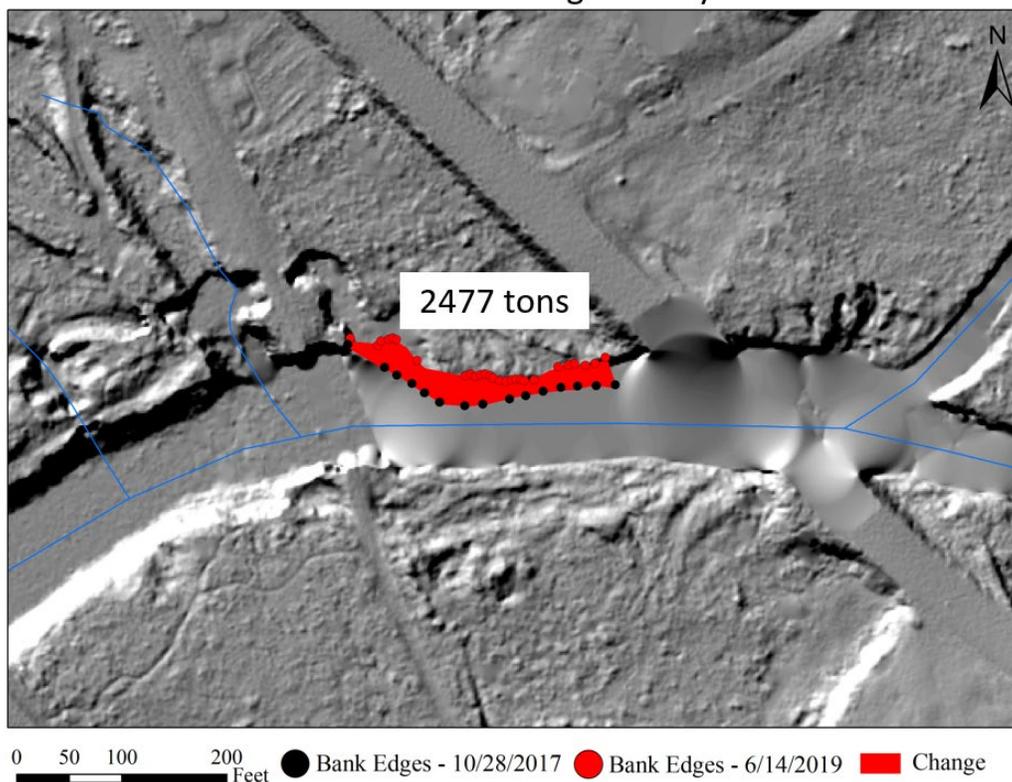
Hiestand Sawmill Dam – Bank Edge Survey 2017 vs 2019

Figure 2: Erosion mapping with Digital Elevation Model differencing

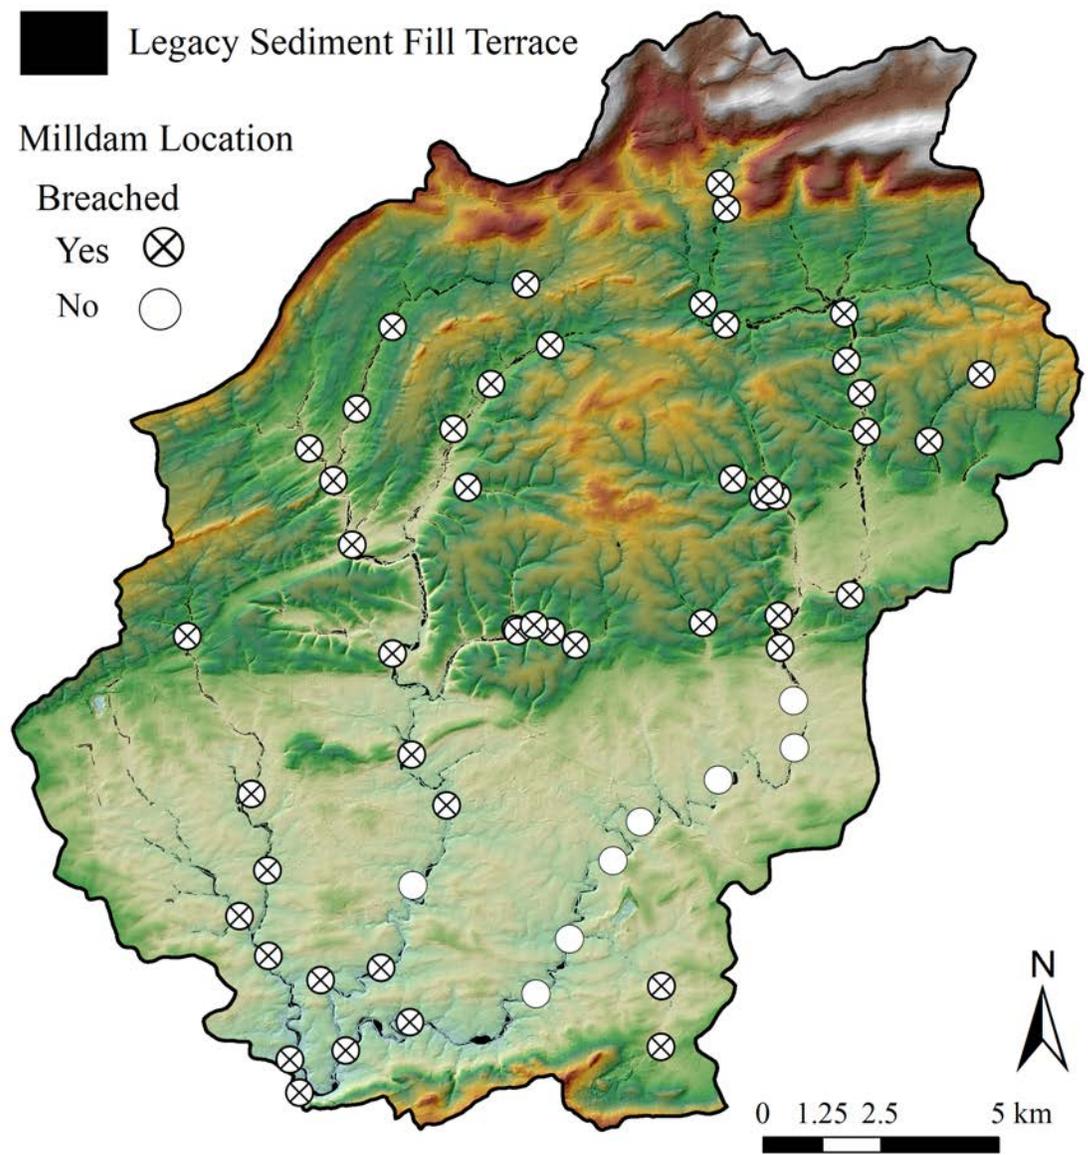
Figure 1. We mapped 54 historic dams (breached and unbreached) in the Chiques watershed, and used historic reports, documents, aerial photographs, and other sources to determine breach condition. We mapped historic sediment (black) using airborne lidar from 2014. This work began as a senior independent study project by Logan Lewis in 2017-2018. Logan has continued and built upon this work at WSI since then. (Figure is copyright WSI; please request permission to use.)

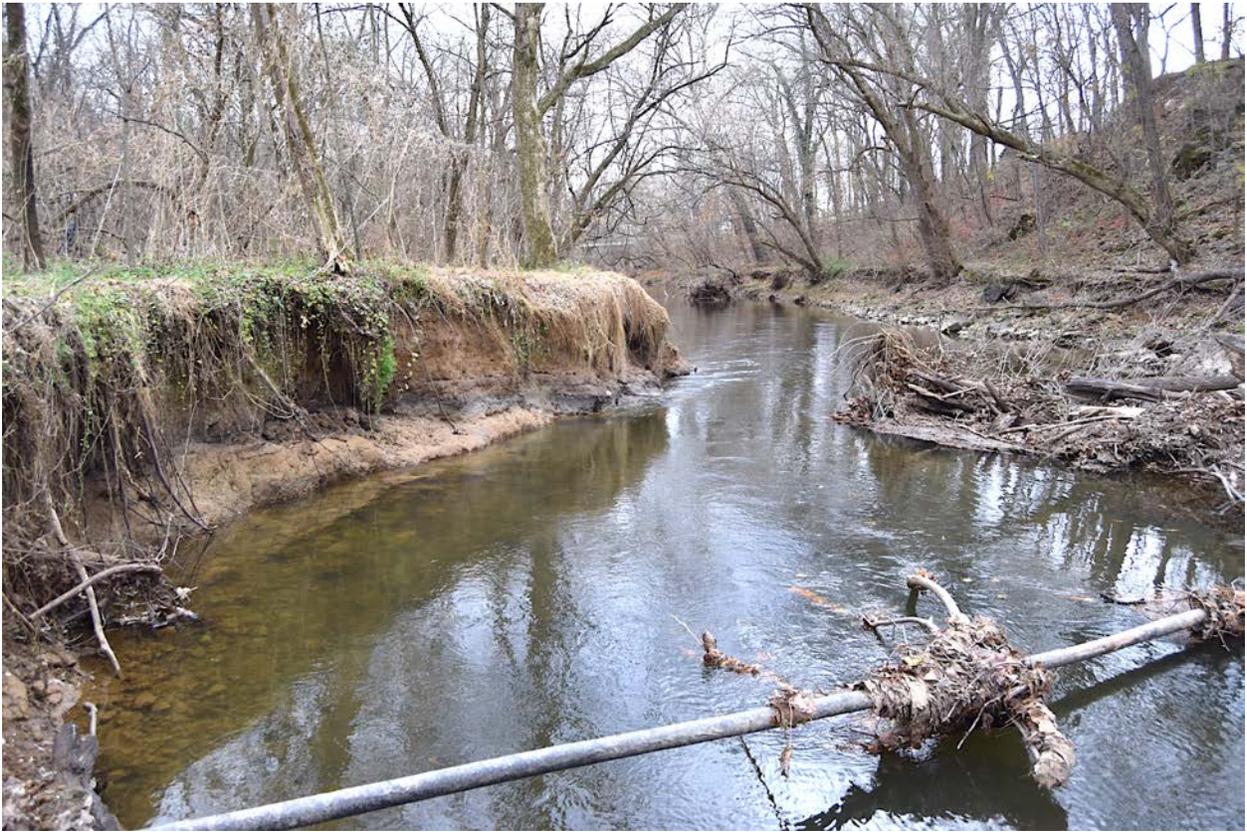
Figure 2. Deep incision of Chiques Creek since removal of the Krady milldam in July 2018 resulted in ~3.1 m high banks and from top down has exposed 1) historic legacy sediment that is mostly silt, 2) dark organic-rich Holocene sediment from a pre-European settlement wetland, and 3) slightly oxidized pebbly, cobbly colluvium from mass wasting that is likely Pleistocene in age and the result of permafrost thaw. Limestone bedrock underlies these sediments. Note that the legacy sediment and underlying Holocene wetland soils thicken to the right because they are draped over the pre-existing valley topography with a small hill to the left.
